Technical Report ARMET-TR-15001

**CANNON WEAR AND EROSION SCIENCE AND TECHNOLOGY OBJECTIVE
PROGRAM (STO) 155-MM PROJECTILE ROTATING BAND/OBTURATION
FOR EXTENDED RANGE**

June 2015

U.S. ARMY ARMAMENT RESEARCH, DEVELOPMENT AND
ENGINEERING CENTER

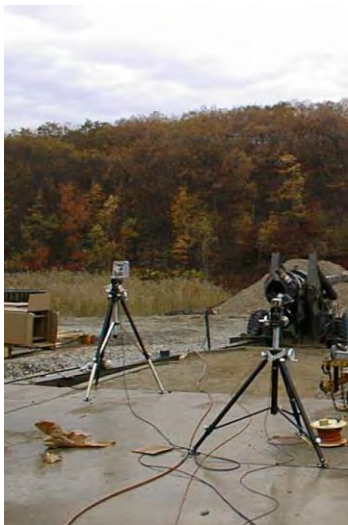
Figure 16
ARDEC low-zone sticker test

After the YPG test, the CPC program continued to evaluate the two down selected nickel and stainless steel rotating bands in another low-zone sticker test. This low-zone sticker test was conducted on October 21, 1998 at ARDEC. The test objective was to verify that the new design would be adequate in satisfying the low-zone application. The low-zone sticker test again used a 1st quarter M199 gun tube. A total of nine rounds were fired, which included two CPC BTPs with nickel rotating bands and two with stainless steel rotating bands. The M864 projectile rounds and PXR6325 projectile rounds were also fired. The test results showed that the new design was adequate in satisfying the low-zone application. The test results also showed that the reduced effective length of the rotating bands using nickel and stainless steel did not affect the performance of the projectile at high-zone firings.

CPC BTP with nickel and stainless steel rotating bands

The average pressures obtained for the CPC BTPs with the nickel and stainless steel rotating bands were about 10,000 PSI and 11,750 PSI, respectively. The average velocities were in the neighborhood of 282 to 285.9 m/s. The M864 projectile rounds and PXR6325 projectile rounds obtained lower pressures and velocities due to the fact that they are 7 to 10 lb lighter than the CPC BTPs. All projectiles were successfully fired and no sticker problems were encountered. After a review of all the test results and firing data along with recovered projectile analyses, the CPC program members down selected to a candidate nickel rotating band design and an AMODEL obturator as the most viable solution for new ERO. Stainless steel was a good candidate material also; however, its exceptionally high tensile and yield strength and very high melting point require it to be further evaluated through more advanced design configurations.
